## RE: Summary of Transit phase 2 project results

We first want to thank you for contributing your products for use in the Copper in Transit (CIT) trial on Vancouver and Toronto transit vehicles. During the study, Trimco's products were randomly installed on stanchions on 3 buses and 4 SkyTrain cars in Vancouver and 3 buses, 2 subway cars, and 2 streetcars in Toronto. All transit vehicles were assigned to high ridership routes. Each copper stanchion had a mirror control directly opposite. These surfaces were audited every month for durability and every two months for microbial analysis by Westech Inc. - an independent auditing firm. Audits occurred 1-3 hours after peak morning rush hour use. Durability audits consisted of visual damage reports, RGB colour readings, magenta % readings, and copper concentration measurements. Microbial audits were performed prior to vehicle cleaning and disinfection and consisted of bacterial collection and enumeration using Petrifilm<sup>™</sup> aerobic count plates (in triplicate), and measurement of residual organic material with ATP Bioluminescence (ATPB) (single sample). At six and twelve months, select stanchions containing Trimco products were

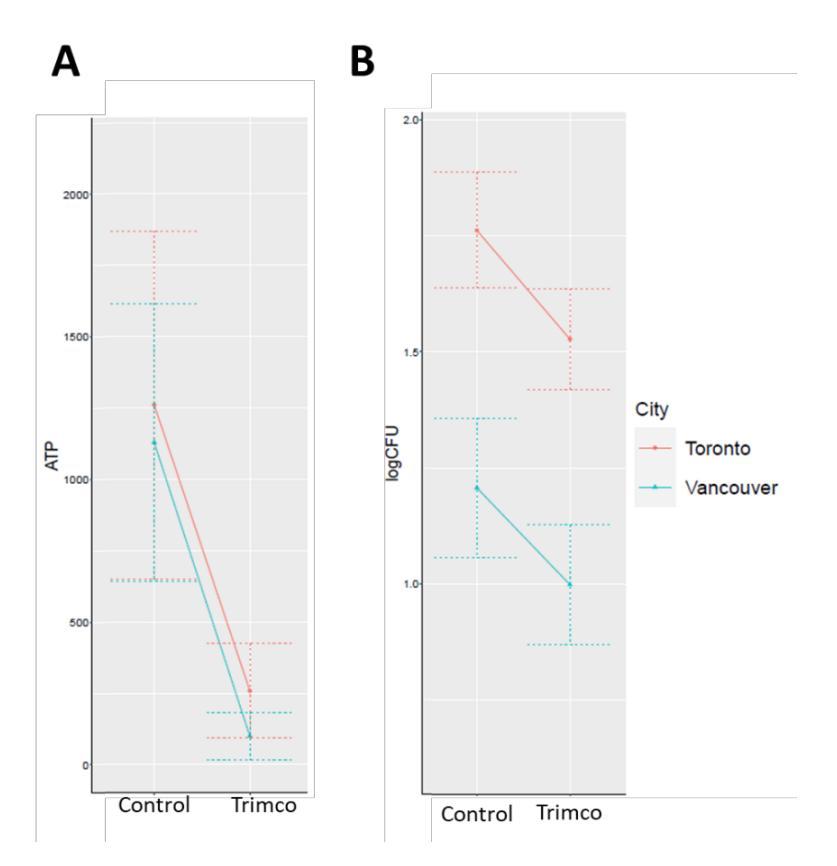
Results after 12-months in situ use for A) ATPB and B) log10 CFU counts

After 12 months of in-field use Trimco's Cu covers exhibited a 39.7% reduction in mean CFU counts and 85.6% reduction in ATP RLU. CFU differences between SS controls and Trimco were higher in Toronto compared to Vancouver, with the highest volume observed on subway cars. This can be attributed to the higher population density in Toronto, with subways having the highest turnover of users. In comparison, the ATP RLU reading were similar between Toronto and Vancouver. As ATP measures all cellular matter (fungi, viruses, skin cells, pollen, etc.) this could be attributed to Vancouver having a more temperate climate which is more optimal for growth and survival of organic material, overcoming the population differences.

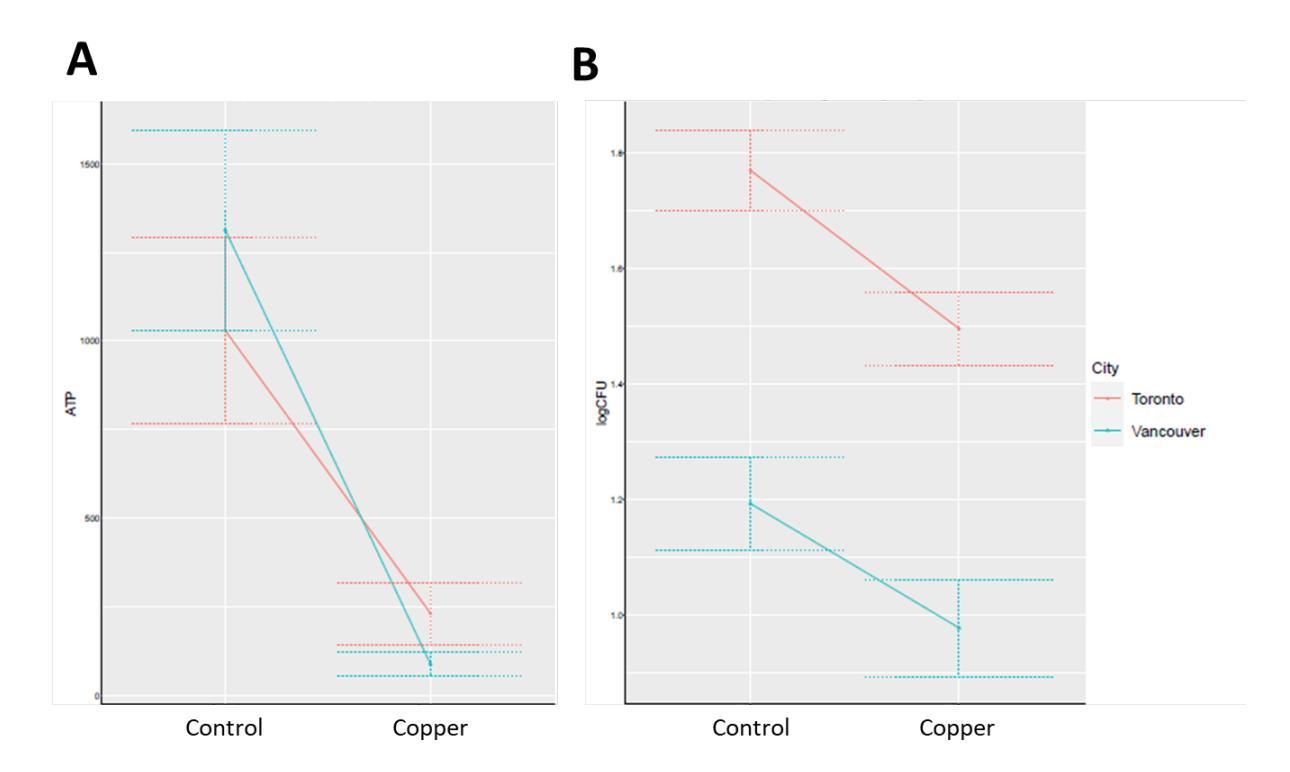
## Aggregate of all Cu products results after 12 months of use in field for A) ATP and B) log10 CFU counts

Overall, the microbial efficacy of the 3 different Cu products combined (compared to SS) exhibited a significant 42.7% reduction in mean CFU and an 87.1% reduction in ATP RLU.

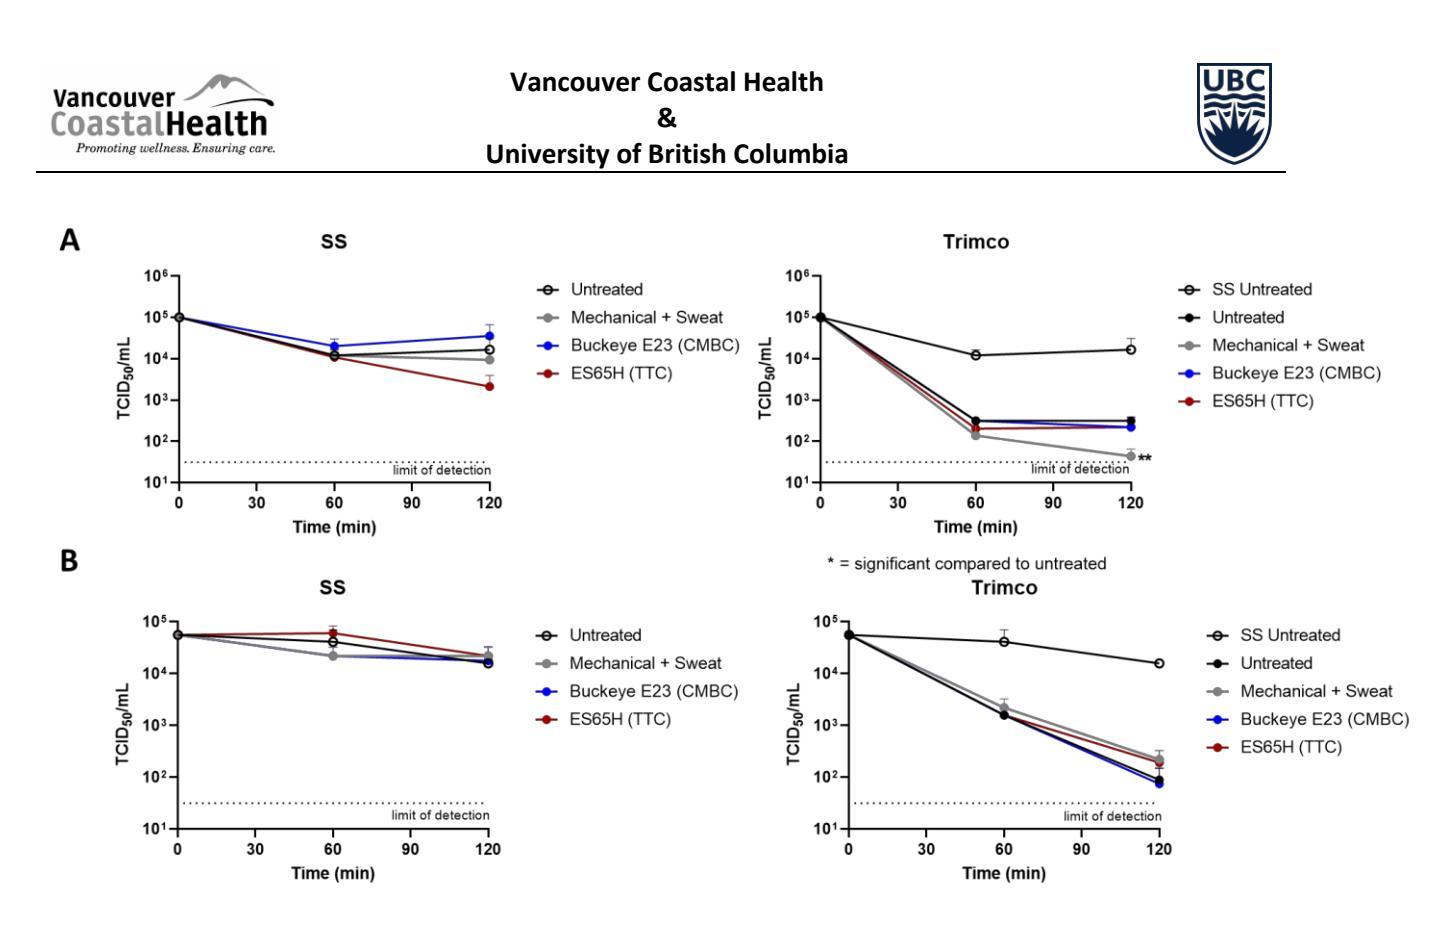
Antiviral efficacy after 200 rounds of cleaning with disinfectants or artificial sweat for A) SARS CoV-2 analog and B) norovirus analog

For virucidal analysis, SS and Trimco surfaces were inoculated with MNV-1 or 229E with a range of 1-5 x10<sup>5</sup> TCID<sub>50</sub>/mL in artificial sweat-cell media mixture for 1 and 2 hours. Results are based on triplicate samples and demonstrate that rubbing with artificial sweat for 200 rounds significantly enhanced the antiviral capabilities of Trimco for 229E but not MNV-1. For 229E, Trimco coupons showed an average percent reduction in virus of 98.3% and 96.4% at 1 and 2 hours, respectively. After 1 hour with MNV-1, viral load was reduced by an average of 94.8% which increased to 99.4% after 2 hours.

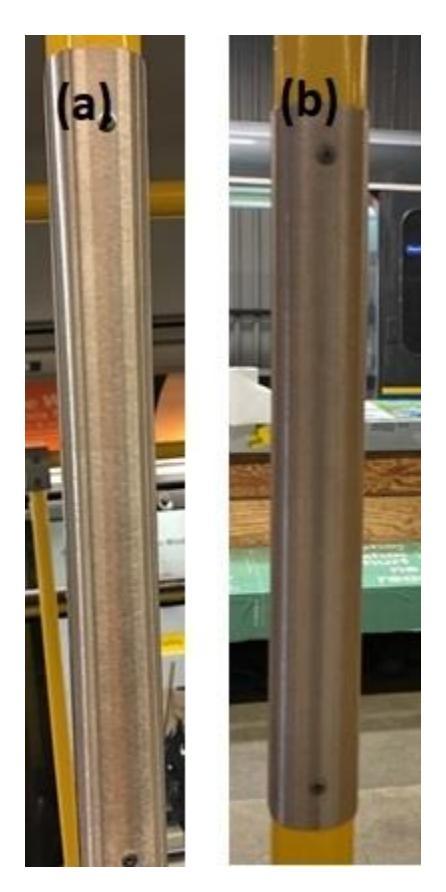
Trimco stanchions: (a) just after installation, (b) after 12 months of installation, where stanchion is getting darker, possibly due to oxidation or carbon-contamination of the stanchion resulting from daily usage.

The colorimetry measurements revealed that on average, the Trimco products became darker after installation and use , likely due to oxidation or carbon-contamination of the stanchion resulting from daily usage.

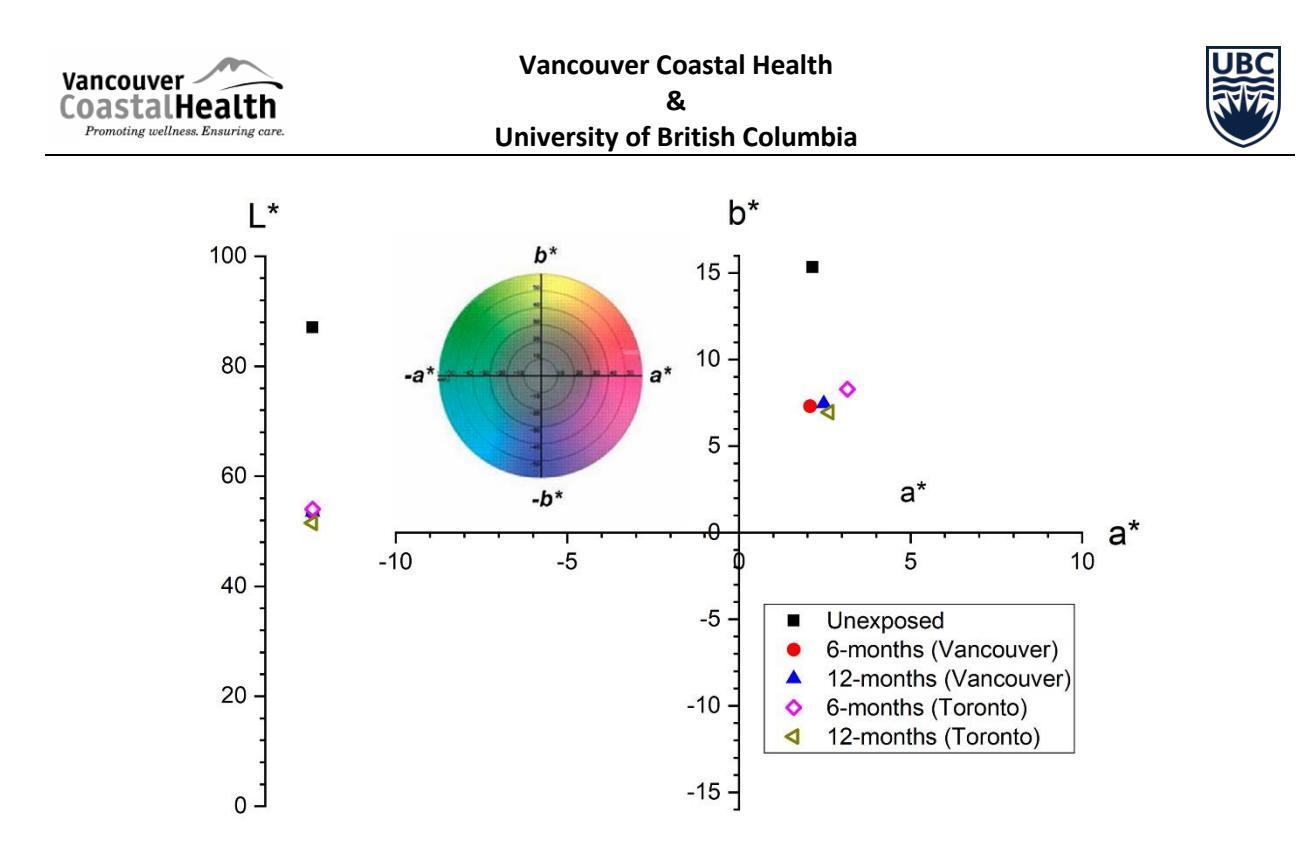
The average changes in the surface color of the stanchions were analyzed using colorimetry. The surface appearance was described using the three coordinates, a\* (red/magenta-green), b\* (yellowblue) and L\* (lightness-black to white) in the CIELab color reference space. The a\* value represents the degree of redness/magentaness (-a\*) or greenness (+a\*) of a color, the b\* value represents the degree of yellowness (+b\*) or blueness (-b\*), and the L\* value represents the lightness of a color, ranging from black (0) to white (100). Decreasing values for a\*, b\* or L\* toward 0 indicate that the surface of copper is getting darker, possibly due to oxidation or carbon-contamination of the stanchion resulting from daily usage.

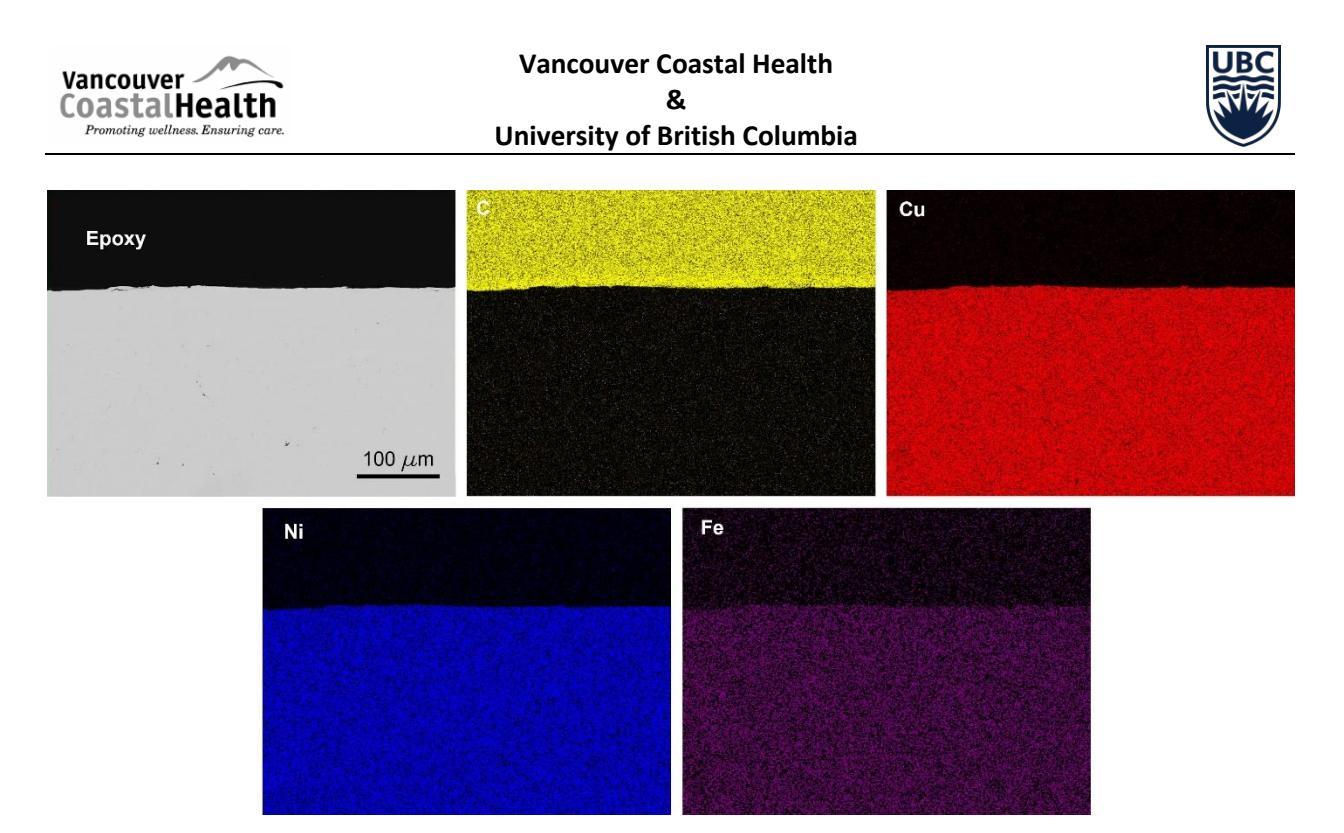
SEM-EDS cross-sectional analysis of as-received Trimco product.

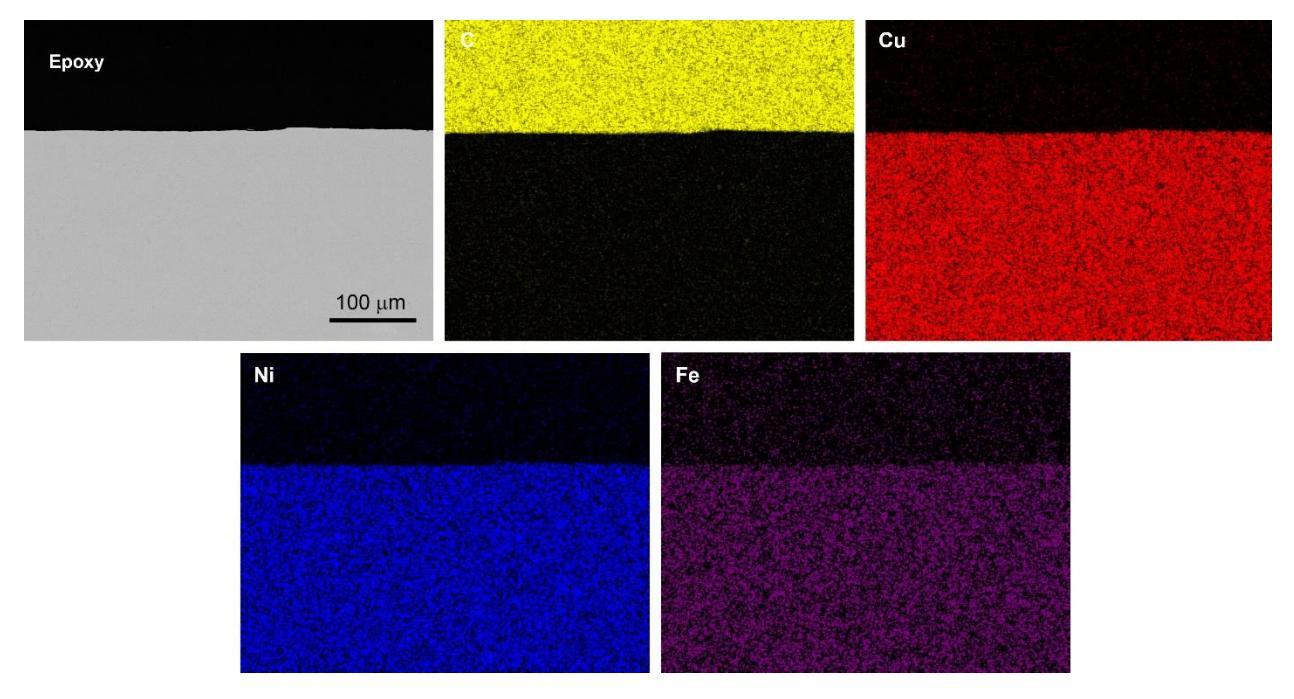
SEM-EDS cross-sectional analysis of Trimco product after 6 months of installation in SkyTrain. No significant damage to the material was observed.

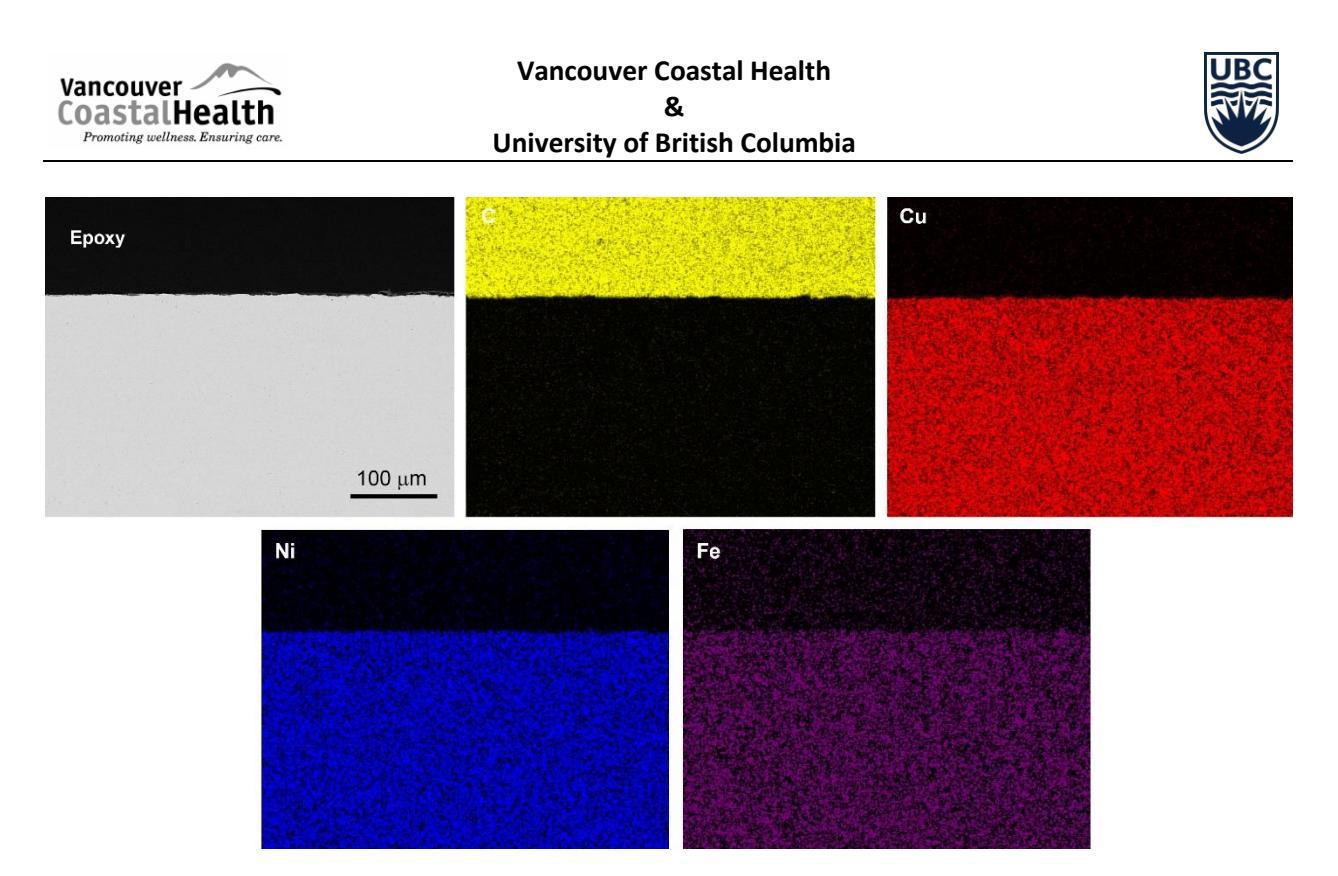
SEM-EDS cross-sectional analysis of Trimco product after 12 months of installation in SkyTrain. No significant damage to the material was observed.

After 12 months of installation, the EDS elemental cross-sectional analysis did not indicate any signs of dealloying. Top-down EDS maps of all three surfaces used for 12 months revealed the presence of a considerable amount of carbon-containing substance (carbon-contamination). This contamination reduced the effective copper surface area, potentially decreasing copper release. The carbon-contamination was observed to be more concentrated in surface crevices and grooves.

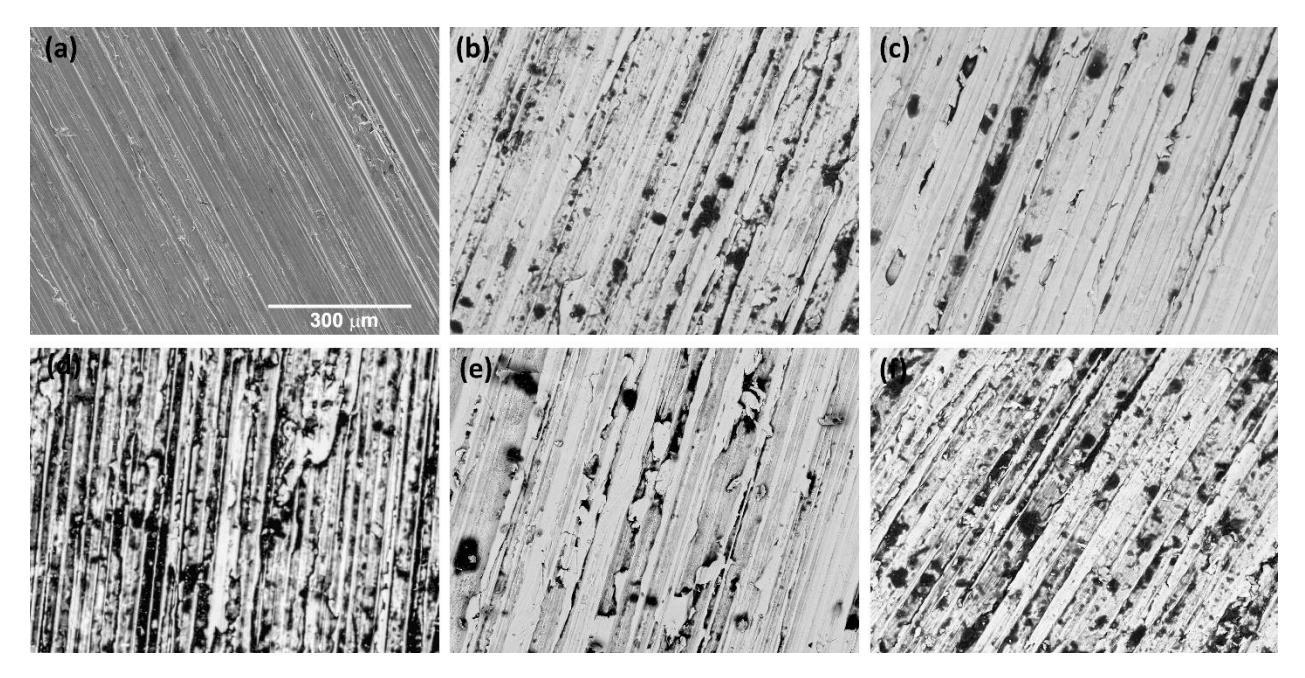
Top-down SEM images of the Trimco products: (a) as-received, (b) after 12 months of installation in CMBC Bus, (c) after 12 months of installation in SkyTrain, (d) after 12 months of installation in TTC Bus, (e) after 6 months of installation in TTC Car, and (f) after 6 months of installation in TTC Sub. Please note that the scratches visible in the SEM images are a result of the production process and are oriented perpendicular to the long axis of the stanchion. Black areas are carbon contamination.
